Re: **Mr. Michael Salazar Private Homeowner Construction Site; Construction Stormwater; SIC 1522; NPDES Compliance Evaluation Inspection; NPDES #NMU001979; September 20, 2018**

NPDES Compliance Inspection Report

Further Explanations

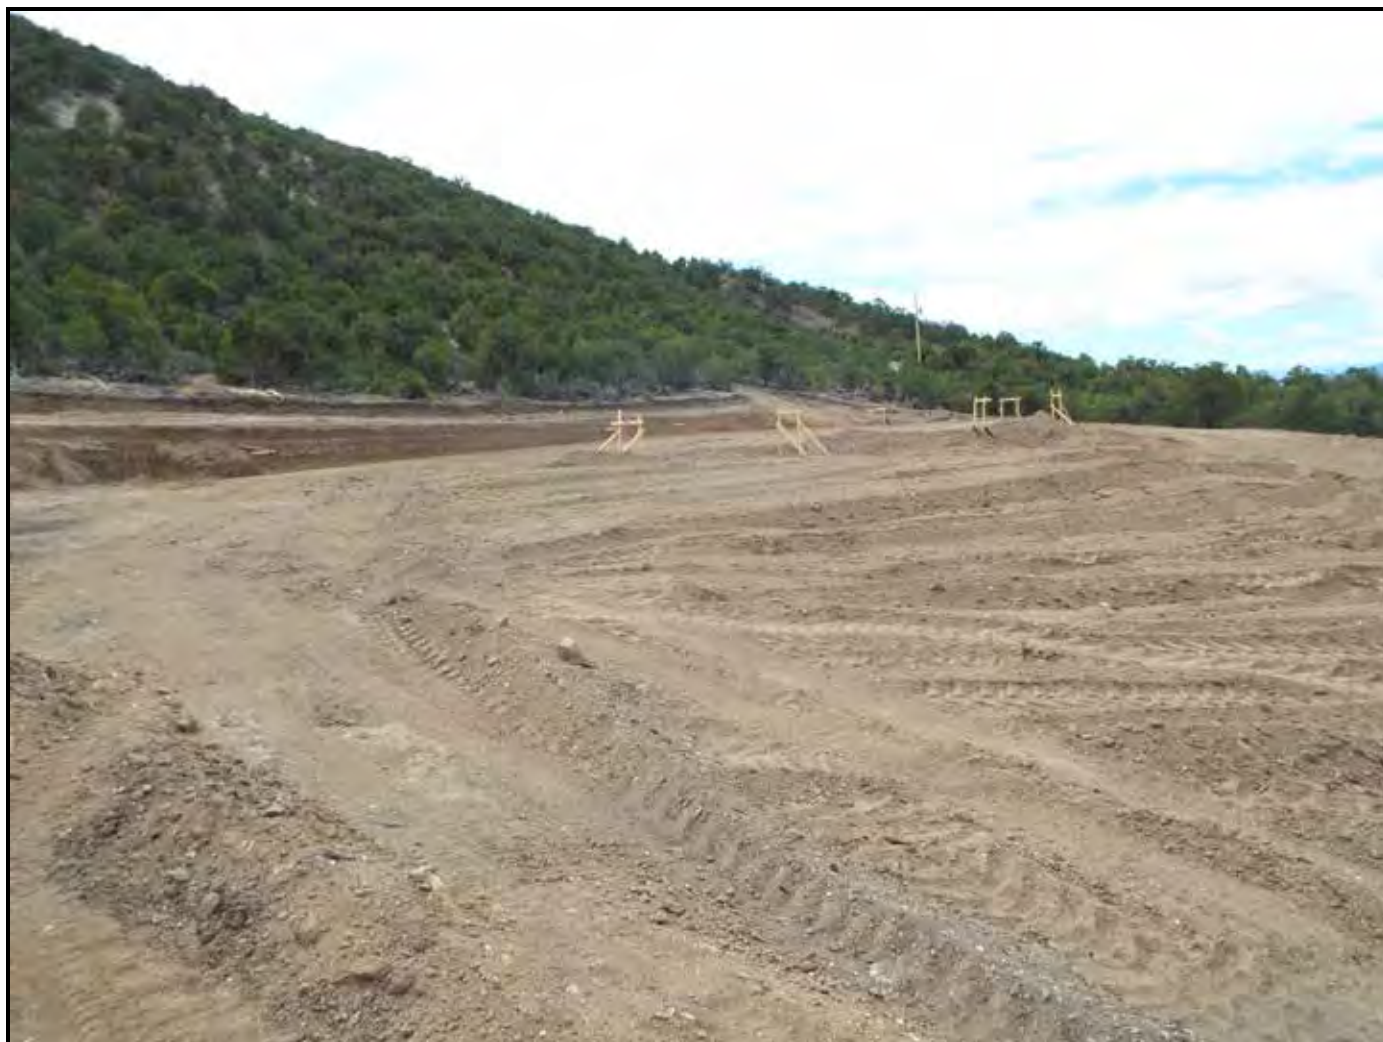
Photo # 1

Photographer: Daniel Valenta	Date: September 20, 2018	Time: 1409 hours
City/County: Talpa/Santa Fe		
Location: 67B Torres Rd., Village of Talpa, New Mexico 87557		
Subject: Residential construction site.

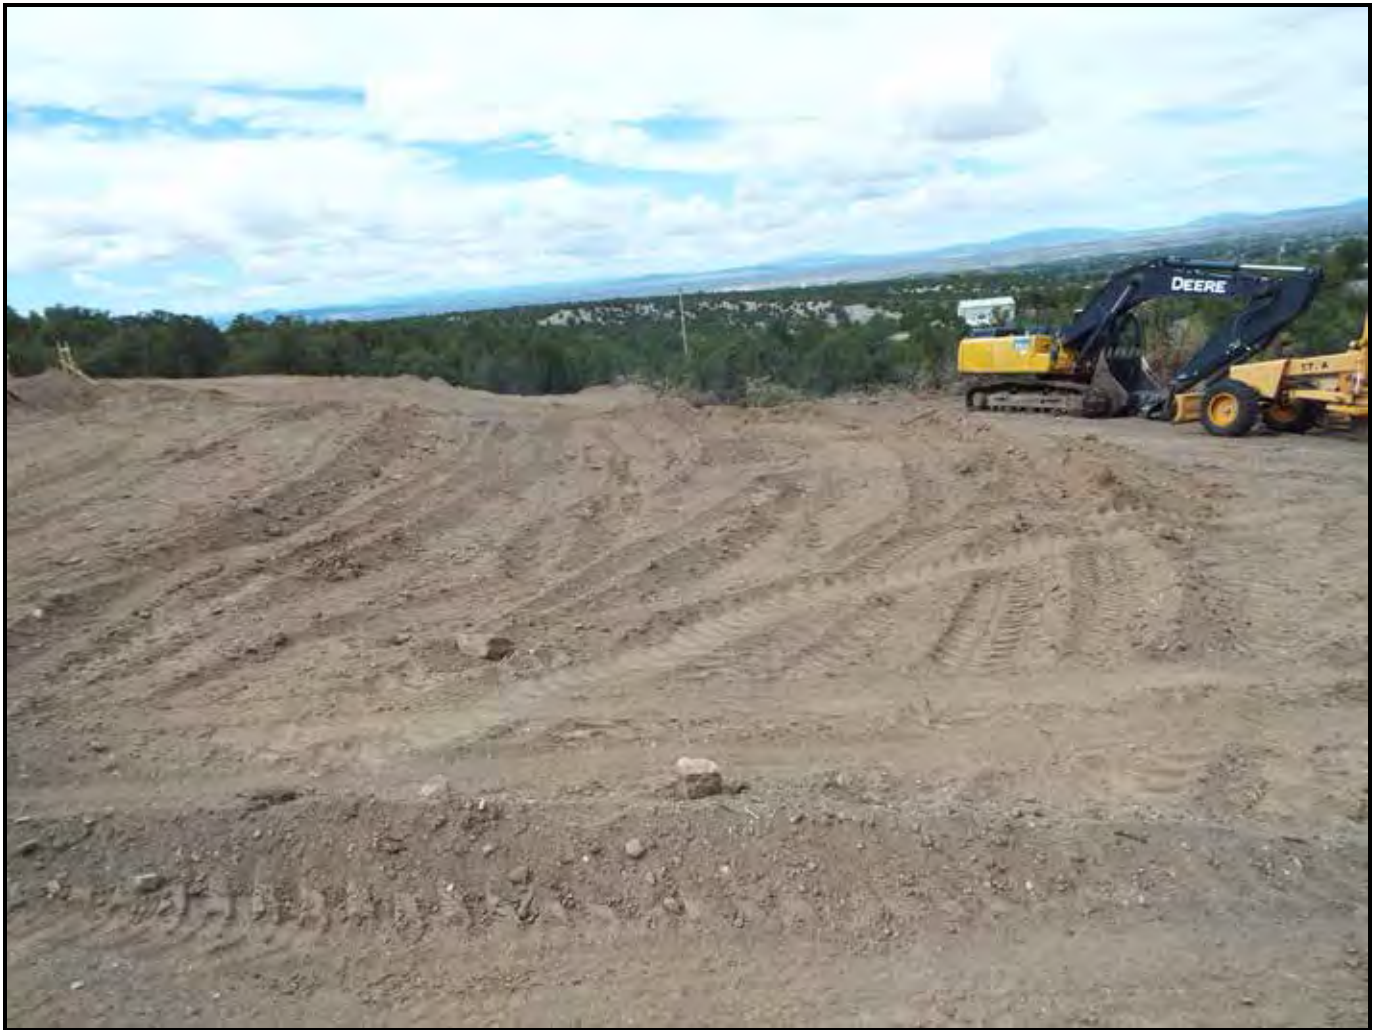
Photo # 2

Photographer: Daniel Valenta	Date: September 20, 2018	Time: 1409 hours
City/County: Talpa/Santa Fe		
Location: 67B Torres Rd., Village of Talpa, New Mexico 87557		
Subject: Residential construction site.
